NIN	l	
I	BFN <sub>-</sub>	_HUB_	_CST_	NOT_	_0001
Light Failure at FLiDAR buoy E26

Date	10 Feb 2025
Revision	2

## **Notice to Mariners**

## 1. Broadshore Hub Offshore Wind Farms - Floating LiDAR Buoy E26 Confirmed as Unlit

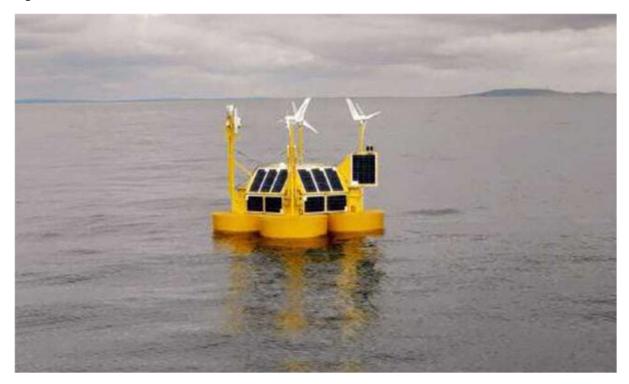
Figure 2: Broadshore FLIDAR E26

Please be advised that the Broadshore Hub Offshore Wind Farms' Floating LiDAR buoy E26 has been confirmed as being unlit. The project team is currently arranging its repair and will confirm via updated Notice to Mariners when the repair will be undertaken, and also when the repair is complete.
